CAPITAL IMPROVEMENT PROGRAM

City of Missoula CIP Project Request/Update Form FY 2018-2022

RE: Grant Creek Between I-90 and Prospect Drive

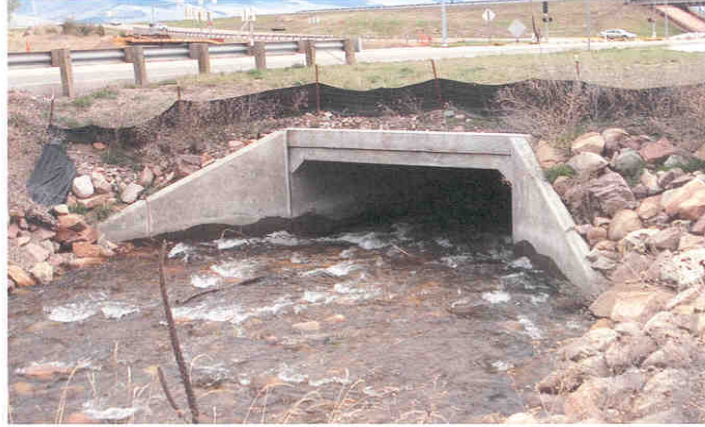
#1

My first concern is with the debris collecting on the bottom of the box culvert or being moved into the box culvert during high water. I doubt if anyone regularly inspects the interior of the culvert. Unlike most culverts, the irregular bottom is ideal for trapping debris. If a blockage took place during any significant event, no one could clear it by entering either end for fear of drowning. Flood flows would then crest and flow under I-90 and down Reserve Street. Grant Creek is rated at 245 CFS for a 10 year, 380 CFS for a 50 year, 465 CFS for a 100 year and 730 CFS for a 500 year storm event. These are significant flows and they will move accumulated debris downstream to the box culvert.

**North end of
800-foot long
(14'x7') box culvert
under I-90 and
Reserve Street
intersection**

I would advise that serious consideration be given to clearing the floodway of accumulated debris, thinning brush, and thickets in the floodway and along Grant Creek Road to provide a safe and healthy riparian area and roadway. I also advise that the box culvert be inspected and a debris trap be constructed upstream of the box culvert.

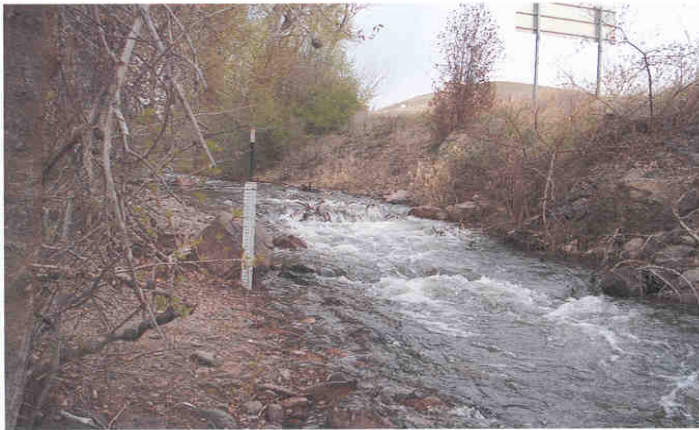
#2

**Stream gauging
station between I-90
and Expo Parkway**

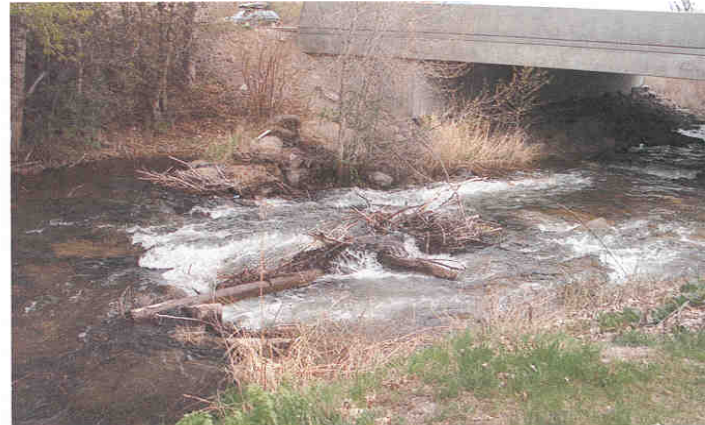
#3

My second concern is with the upstream channel blockages by fallen trees and debris accumulation in the flood way. Trees that have fallen across and into the channel creating barbs that direct flows against the side of the channel and possibly the levee or Grant Creek Road. During a major event, the accumulated debris will collect on fallen trees creating dams that will raise the 100-year flood profile, placing adjacent property and improvements at risk. If water ever exited the west side of Grant Creek, it would not have a chance to get back into the channel before it discharged under I-90 and down Reserve Street.

**Logs and debris
upstream of Expo
Parkway**
